**DEPARTMENT OF TRANSPORTATION**

Contract #: 04-0120F4Cty: SF/ALA Rte: 80 PM: 13.2/13.9File #: 1.28**WELDING INSPECTION REPORT****Resident Engineer:** Casey, William**Address:** 333 Burma Road**City:** Oakland, CA 94607**Report No:** WIR-026651**Date Inspected:** 07-Nov-2011**Project Name:** SAS Superstructure**OSM Arrival Time:** 700**Prime Contractor:** American Bridge/Fluor Enterprises, a JV**OSM Departure Time:** 1730**Contractor:** American Bridge/Fluor Enterprises, a JV**Location:** Job Site**CWI Name:** Jesse Cayabyab and Pat Swain**CWI Present:** Yes No**Inspected CWI report:** Yes No N/A**Rod Oven in Use:** Yes No N/A**Electrode to specification:** Yes No N/A**Weld Procedures Followed:** Yes No N/A**Qualified Welders:** Yes No N/A**Verified Joint Fit-up:** Yes No N/A**Approved Drawings:** Yes No N/A**Approved WPS:** Yes No N/A**Delayed / Cancelled:** Yes No N/A**Bridge No:** 34-0006**Component:** SAS OBG**Summary of Items Observed:**

# WELDING INSPECTION REPORT

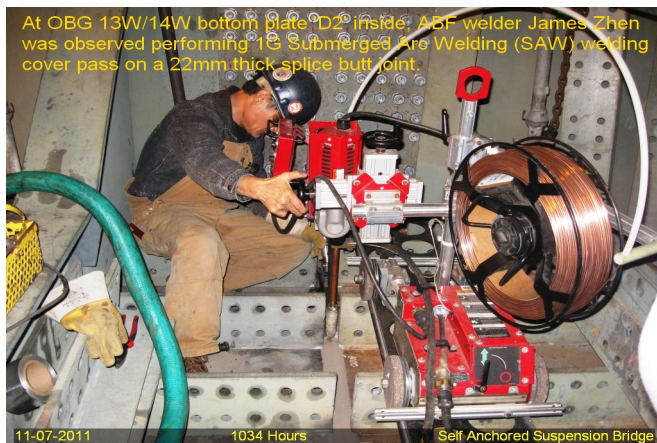
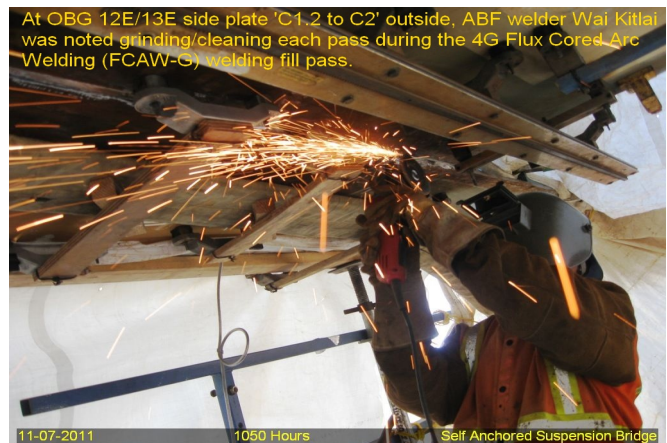
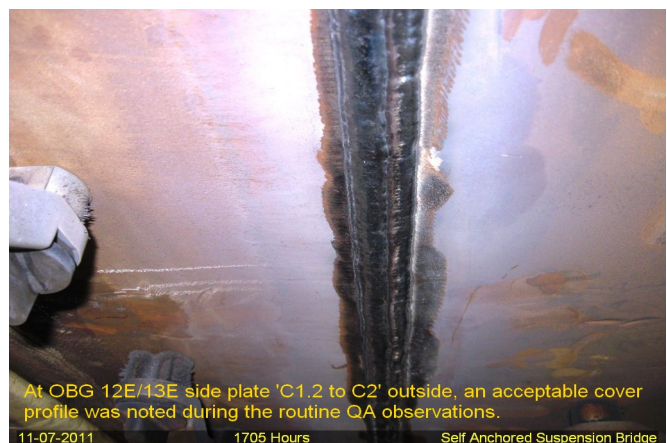
At OBG 13W/14W bottom plate 'D2' inside, QA randomly observed ABF certified welder James Zhen ID #6001 perform 1G (flat position) Submerged Arc Welding (SAW) welding fill pass on the Complete Joint Penetration (CJP) splice butt joint. The welder was utilizing F7A6-EM12K-H8, 3.2mm electrode with corresponding Esab OK Flux 10.62 flux and implementing Caltrans approved Welding Procedure Specification (WPS) ABF-WPS-D15-4042B-1. The joint being welded has a single V-groove butt joint with backing bar. The plates were preheated to more than 200 degrees Fahrenheit using Miller Proheat 35 Induction Heating System heater blankets located at the opposite side of the plate prior/during welding. Welding parameters were monitored by ABF/QC Pat Swain. QA noted the welding parameters, the workmanship and appearance of the completed fill pass deemed satisfactory. During the shift, fill pass welding was still continuing when observations for the SAW welding of the north side of the joint was turned over to fellow QA Craig Hager while this QA was assigned to another welding location.

QA randomly observed ABF/JV qualified welders Wai Kitlai and Jin Pei Wang perform CJP groove back welding fill pass to cover pass on Orthotropic Box Girder (OBG) 12E/13E side plate 'C1.2 to C2' outside. The welders were observed simultaneously welding in the 4G (overhead) position utilizing a dual shield Flux Cored Arc Welding (FCAW-G) with E71T-1M, 1/16" diameter wire electrode and implementing Caltrans approved Welding Procedure Specification (WPS) ABF-WPS-D15-3110-4. The welder was using a track mounted welder holder

assembly that was remotely controlled. The joint being welded has the backing bar gouged using the Esab Plasma Arc machine and was ground smooth. The gouged and ground splice butt joint was also Non Destructive Testing (NDT) tested using the Magnetic Particle Testing (MT). The splice joint was preheated to greater than 200 degrees Fahrenheit using Miller Proheat 35 Induction Heating System with the heater blankets located on top of the plate prior welding and maintained by moving the heater blanket at the side of the plate being welded during welding. The vicinity was properly protected from wind. During welding, ABF Quality Control (QC) Jesse Cayabyab was noted monitoring the welding parameters of the welder. At the end of the shift, cover pass welding was completed and the welders have held the preheat of more than 200°F for three (3) hours as required.

At OBG 12W/13W side plate 'C' outside, ABF Bernie Docena was observed performing Magnetic Particle Testing (MT) on the carbon arc gouged and ground removal of the backing bar. QC has found no significant defects during the test. After the completion of the MT, ABF welders Rory Hogan and Jeremy Dolman have prepared the joint and set up the Bug-o track for the back welding of the splice butt joint. The welders have also prepared the Miller Proheat 35 Induction Heater blankets in preparation for the preheating of the joint during welding.
